Walton Supply Resilience (Chessington) - Pump & Surge Vessel Grouting Failures

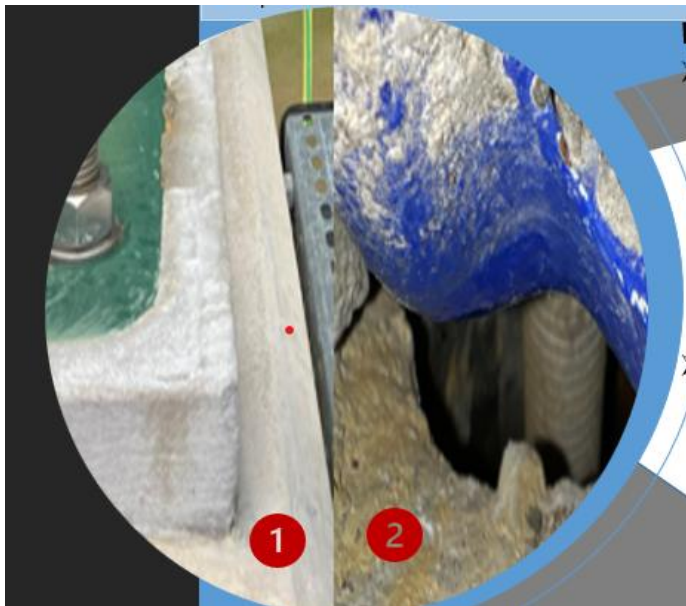
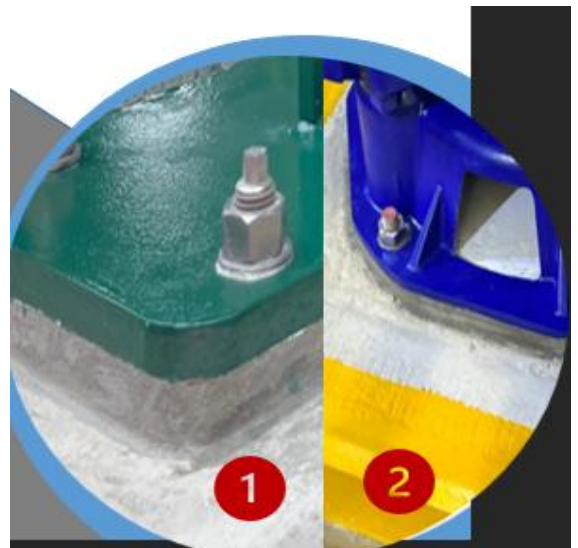
Structural issues occurred due to improper baseplate grouting practices. Grout was mistakenly applied on top rather than beneath the baseplates, undermining proper load transfer and compromising structural integrity. Furthermore, an improper unfilled void beneath the pump's slab led to grout settlement. The absence of correct grout finishing, such as chamfering and confinement, resulted in cracking. These failures indicate significant shortcomings in procedural compliance and communication.

- **Grout Removal and Void Filling:** Excess grout was precisely trimmed from the affected areas, following the MWH design team's instructions, we then filled the existing void and around the exposed pump's bolt with appropriate TS and BB grout.
- **Plinth Repair and Finishing:** Damaged plinth surfaces for both the pump and surge vessel were repaired and repainted to restore their integrity and appearance.
