Safety Alert 24-112 Electrofusion Coupling Fire – Peckforton WTW

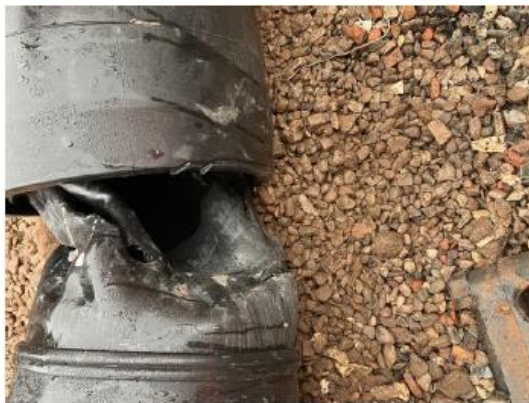
When the weld had finished, the team were packing the equipment away and noticed smoke coming from the fitting, this then turned into a flame, causing damage to the fitting and the attached pipework.

Photo 1: Damaged Pipework

- Check all electrofusion fittings are in good condition prior to use.
- Ensure the correct welding time is used.
- Never re-weld a failed fitting, these must be cut out, and a new fitting used.

- Manufacturers instructions/guidance must be followed at all times.
- Never re-weld a failed fitting, these must be cut out and replaced. The failed fitting should then be sent off to the manufacturer for analysis.
- Check to see if the pipe has a constant airflow, if this occurs, find a way to block the airflow from continuing, as this could cause a backdraught effect inside the pipework.
- Ensure fittings are not damaged and the correct procedure is followed when installing the pipework.
- The SSOW must be comprehensive and address all potential risks associated with the work.

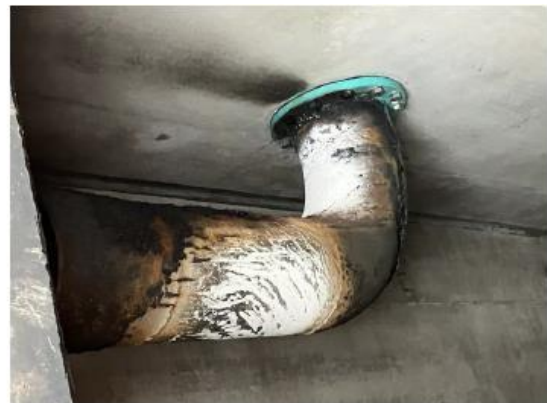
The fire caused damage to the paint on the carbon steel pipework inside the wash water tank, this now needs to be removed and replaced.

Photo 2: Damage to the internal pipe
