Safety Alert 24-03 Petzl Harness

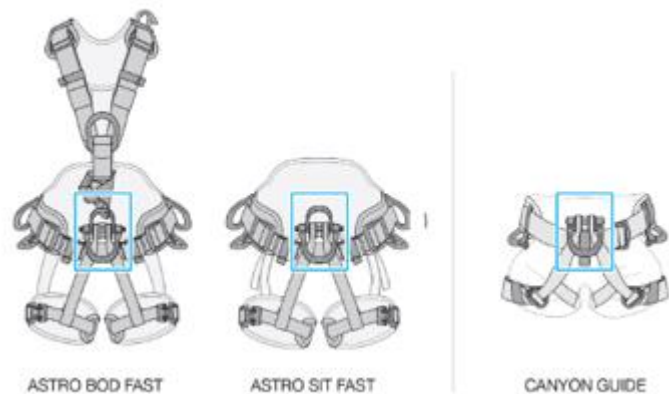
Origin and consequences of the defect

Defect is due to a poor machining process of the metal D. This can cause the pin to slide completely sideways, despite the presence of the 2 screws. This situation presents a risk of death due to strangulation or falling from height.

1. **ASTRO BOD FAST**, **ASTRO SIT FAST** and **CANYON GUIDE** harnesses to be removed from use, placed in Quarantine for inspection and reported
2. **ASTRO BOD FAST**, **ASTRO SIT FAST** and **CANYON GUIDE** harnesses to be inspected by on site
3. Cascade information to contract partners
