Learning Alert 25-04 Lost Time Incident – Roundhill Injured Elbow

The following Safety Alert contains content from an external source which is relevant to MWH Treatment Operations

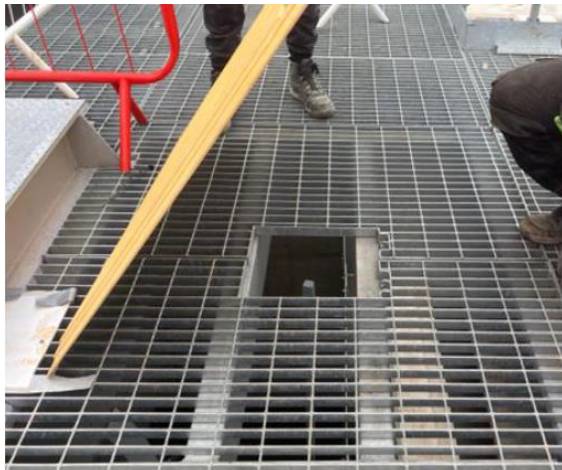
Whilst working on an open mesh floor covering to the TSR at Roundhill a pipework fitter stood on an unsecured piece of open mesh flooring hatch, (approx. size 250mm x 250mm) which fell through the floor. The fitter's fall was broken by his elbow with the right elbow taking the brunt of the impact. Medical examination showed no fracture to the elbow but has resulted in the IP being unable to work for more than 7 days and is therefore a RIDDOR reportable incident.

Photo 1: Hole (being covered by temporary floor)

- The hatch hinges were not seen as a priority task to complete by the subcontractor. It was not perceived as a big risk and were left off daily job lists.
- An adjacent piece of flooring had been approved for modification, but these changes were not checked against design drawings for any potential clashes.
- Time Vs Risk. There was an opportunity to save time by using a different contractor for the modification. This was not subject to a quality check post modification.
- This work area was “permanent works in a temporary state” and was not safe. It is common practice to not manage permanent works under temporary works process.
- Protective foot plates were put in place in the area to cover the unsecured hatches, but these items were not managed in line with our temporary works procedures.

- Check all permanent works in a temporary state has been identified and manage the SHEQ risks in line with the Temporary Works process.
- As part of Contracts Managers' checks ensure all items are on the Temporary Works Register and are suitably managed.
- Where opportunities to save time present themselves, get considered opinion on the potential SHEQ risks involved. Consult our Design team where appropriate.

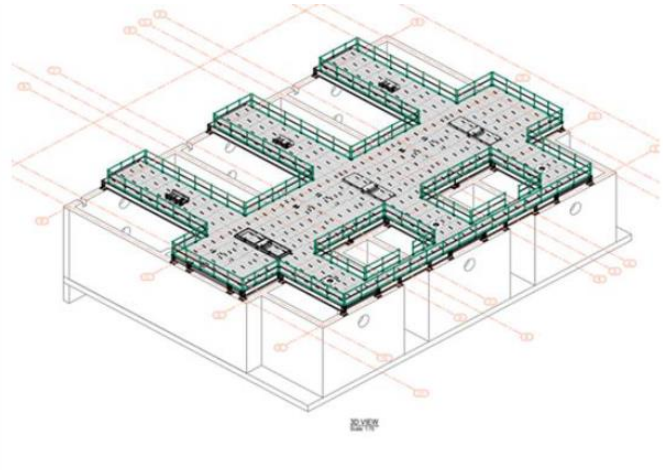
Photo 2: Roof area
