Permits to Pump and Discharges to Watercourses

Permits to Pump and Discharges to Watercourses continued....

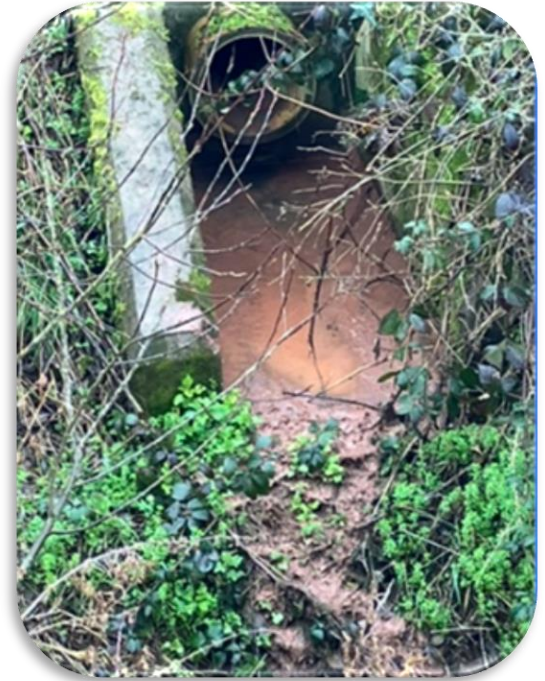
Following a service strike to a live water pipe, an excavation began to fill with water. To avoid the burst pipe being submersed, preventing access and repair, a pump was installed to commence dewatering of the excavation. The resultant waters were discharged to a surface water drain located on the adjacent roadway, which in turn flowed directly to a brook located off-site.

No Permit to Pump was in place for the dewatering activity. A silt sock was also placed on top of the discharge hose, as opposed to being secured over the pipe.

- Following the discovery that the resultant waters had entered the brook via the surface water drain, the pump was immediately turned off.
- The client determined the event as a pollution incident and requested samples to be taken of the brook, to ensure that the ammonia and BOD (Biological Oxygen Demand) levels had not been impacted. No impact to the brook was identified.
- Following the incident, drainage covers were procured to site to prevent future potential contamination of surface water drains.

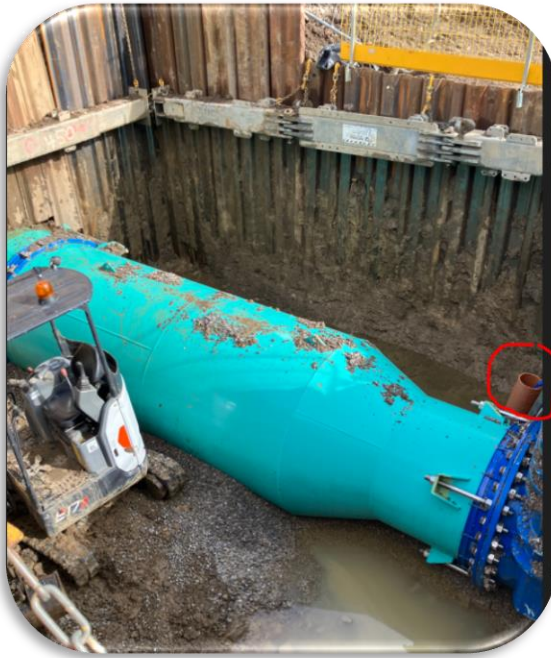
A MWHT Permit to Pump was in place for dewatering from a cofferdam to ground. The discharge point was to ground adjacent to a French drain at the side of the access road. It was decided, two days prior to the incident, to avoid water pooling on the road to put the discharge directly into the manhole (where the French drain runs through) as dewatering was to continue out of hours. The manhole flows to a chamber in which other flows meet and then in turn flows to the brook, which is approximately 150 metres away.

The question was asked on the morning of the incident whether the water had been tested. This was because there was potential it could be potable water from a leaking pipe. When tested at the discharge point chlorine was detected (0.45mg/l) and levels suggested that there is a leak from a process outlet pipe.

- Dewatering was stopped immediately.
- The client was informed immediately. Both the client and MWH independently reported the incident to the Environment Agency.
- Site Drainage Map was reviewed to identify surface water drains.
