## Safety Alert 25-77 11Kva Cable Strike

*The following Safety Alert contains content from an external source which is relevant to MWH Treatment Operations*

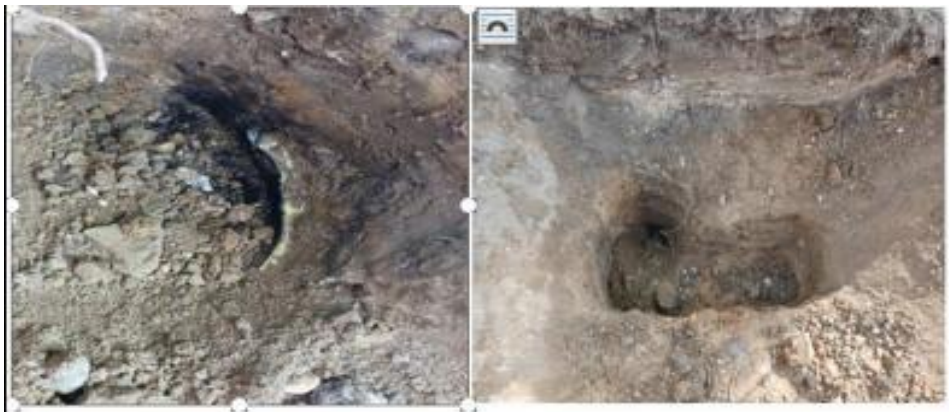
In advance of laying a raw water mains from the existing site to the new site, operatives were tasked with digging trial holes on known services to determine the line and depth of the service, to ensure no impact on the line and level of the mains to be installed. The excavation works proceeded (following a CAT scan to identify the location of the cable) using the hand dig method until they reached the warning tape. The operative then began to dig to the side of the warning tape to further expose the cable and in doing so the spade went through the warning tape and dug into the cable. The ground was stiff clay and there was no sand or stone surrounding the cable, so the operative was digging with force. The operative believed that there would be a gap between the warning tape and the cable, but the warning tape was sitting on top of the cables. The cable blew out and went on fire for a short period. The operative was uninjured as he was using fibreglass non-conductive spade.

- Works were stopped and the excavation barriered off.
- UKPN attended site and de-energised the cable. The excavation was then opened up to allow for the repair of the cable
- 2-2-2 process was followed to alert NWL and Farrans Senior Management of the incident
- Investigation took place into how the incident occurred

- Never assume that the warning tape has the recommended required depth between it and the cable
- When trying to locate a known HV cable, Vacuum Excavation should be the first consideration then if this is not achievable, risk assess the use of an excavator to excavate to the side of the cable (no closer than 500mm) and then continue to manually expose around the cable when the material is easier to remove
