Serious Corrosion Issue on Existing Values

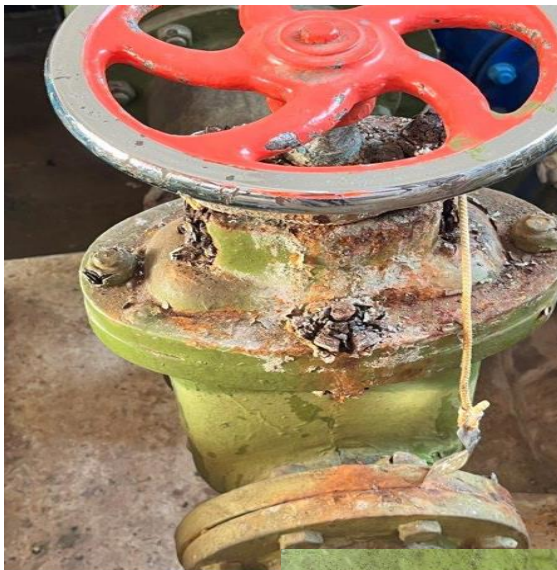
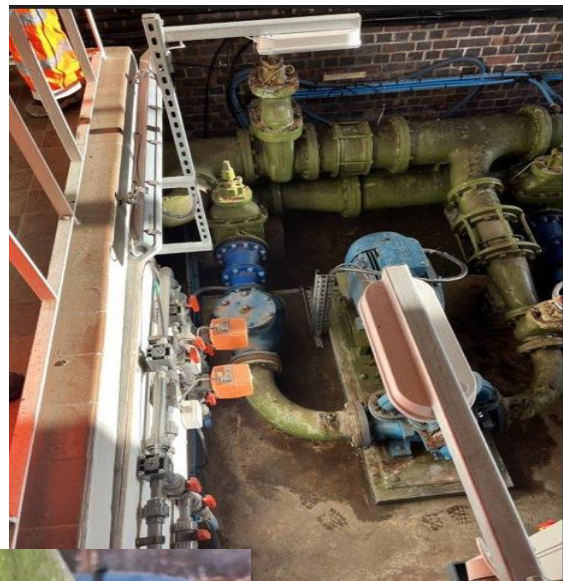
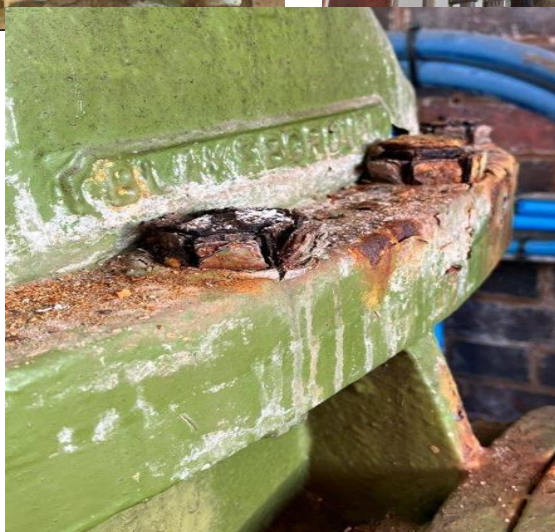
At an MWHT Site, prior to works commencing, serious corrosion issues in the pump station were discovered, including with respect to the condition of the isolation valve on the delivery side of the pump station.

In this instance this was identified by the Mechanical Engineer prior to work starting, however had this not been discovered it could have caused safety issues when isolating the pipework, as well as delays to programme.

Significant
corrosion
issues on
isolating valve

- Ensure for all projects / sites an **existing asset condition survey** is completed as per DEFR08-06 Site Investigation Plan. This can be done in conjunction with the MWHT scanning team.
- Review the condition of any assets that may affect works with the Client and ensure relevant mitigation plans are in place
