## Learning Alert 24-19 Burntwood Service Damage

### Incident Summary?

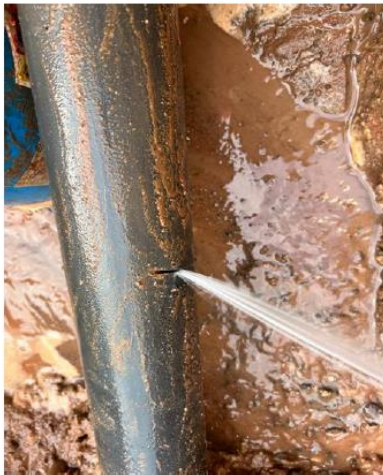
In order to verify whether it was a duct or not, the team used a saw to make a cut in the pipework, this resulted in water spraying out.

Photo 1: Damage To Pipework

A lack of understanding from the subcontractor about procedures when an uncharted service is discovered.

- The supervisor thought it was acceptable to cut into the pipework as a trial to check it was a redundant cable duct. The supervisor did not consult with anyone else on site regarding this.

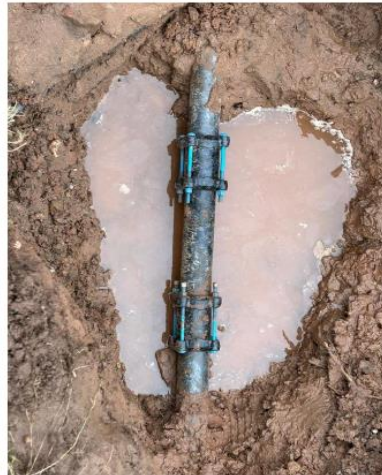
Photo 2: Temporary Repair

Work was stopped and reporting procedures were followed. STW were informed and isolated the pipework, the pipework was repaired and back in service by 6pm.
