Safety Alert 24-130 Electrical Spur Plate Overheating

The following Safety Alert contains content from an external source which is relevant to MWH Treatment Operations

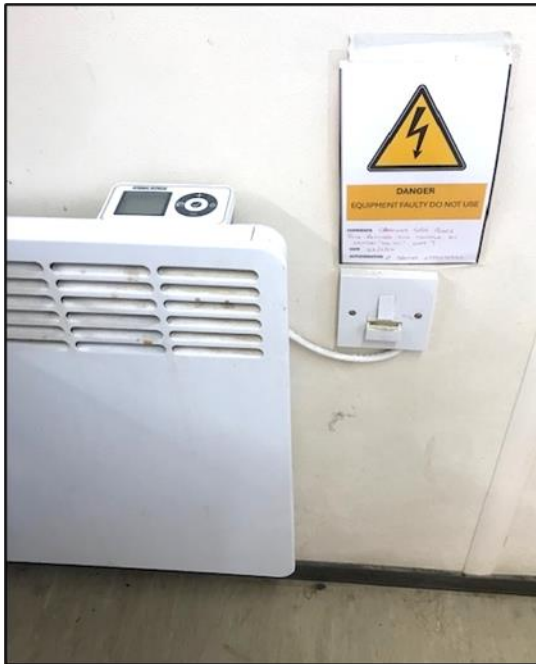
Whilst on site, an Electrical supervisor noticed that there were cracks on the spur plates of 2 separate heaters in the site canteen. Investigation is currently underway; however, the probable cause of cracking is overheating.

The Electrical Supervisor was able to remove the fuses and placed Danger signs at the connections and isolated the heaters.

- All sites to carry out a visual inspection of the spur surface plate for room heaters, checking for any signs of cracks in the face plate and / or overheating. Where damage is identified, ensure the heater is turned down. Notify the cabin owner immediately and request a site visit for further assessment by a qualified electrician.

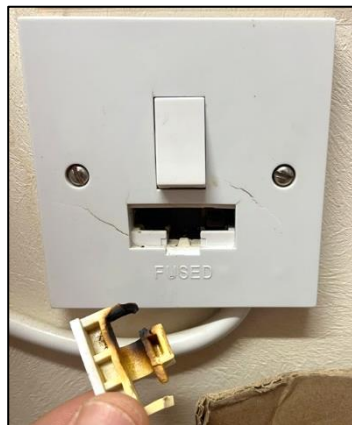
Center photo: Shows scorch marks may be from a loose contact at the fuse connection point. The longer the heater is on, the hotter the loose/poor connection gets.

- Ensure that the heaters are turned down to frost protect before leaving at the end of the day to reduce the risk of overheating.
- Do not store anything on or neat the heaters. The heaters are designed to warm air and can cause overheating creating a potential fire hazard.

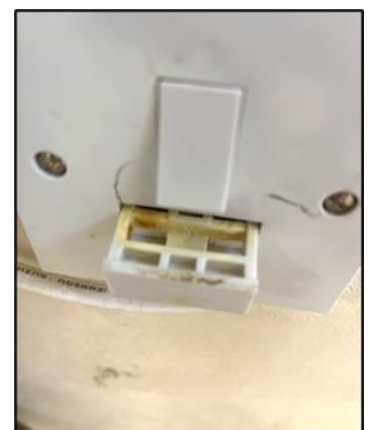
Right photo: The brown marks show where the fuse is inserted into the plate has got warm enough to crack the plate. The damage is less here due to the fact that the heater nearest the kitchen is not used as much.
