## Safety Alert 24-13 Coupled Rebar Failure

*The following Safety Alert contains content from an external source which is relevant to MWH Treatment Operations.*

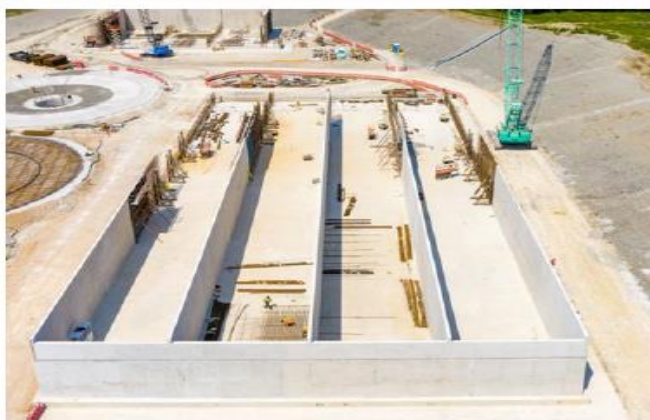
The outlet launder channel to the ASP is connected to the adjacent wall 4m above the ground by the use of reinforcing bar couplers. The couplers were chosen to speed up the construction of the ASP walls by reducing modifications to the wall formwork to accommodate reinforcement.

**Photo 1:** Location of the couplers on wall Y of the ASP

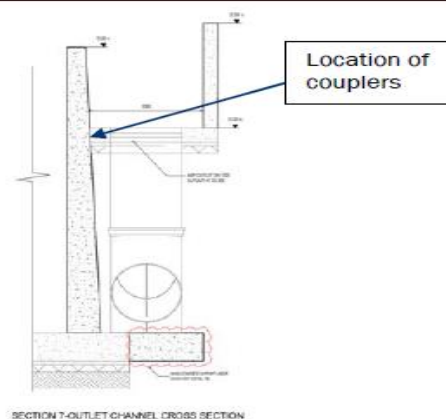
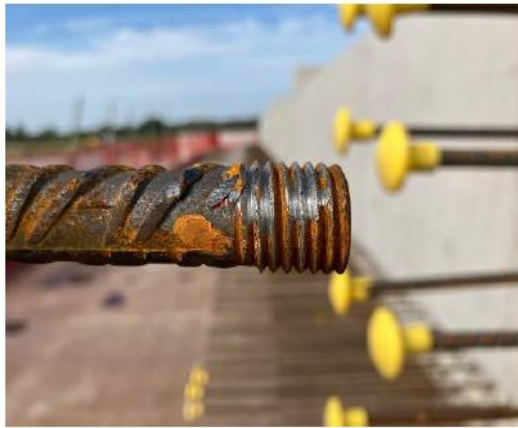
Photo 2: 16mm dia male threaded bar

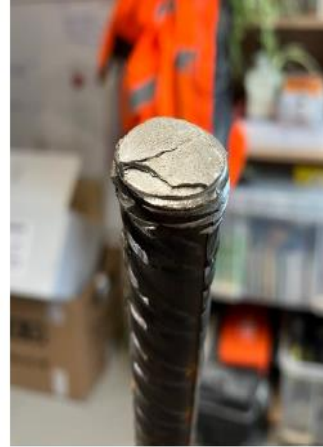
An issue was identified whilst fixing the threaded bar into the coupler. The threaded section suddenly failed under a small shear weight, resulting in the bar breaking from the coupler. Had the site team not noticed, and the soffit poured, there could have been a catastrophic structural failure of the overhanging outlet channel.

Photo 3: Sheared failure at threaded section

- The cause of the failures was due to a worn former on the testing machine used to proof load the bar as part of their quality control procedure. It caused the threaded section to be loaded at an angle, inducing stress and resulting in a fracture beneath the thread.
- The worn former has been replaced and manufacture of replacement bars commenced.
- In house tensile testing of the new bars was undertaken, with MMB witnessing. Further testing of the faulty and new bars was undertaken by a CARES accredited laboratory.
- Fractures were visible in both old and newly machined bars, as a result of machining the thread on the bar. This led the delivery team to change the construction methodology from a cantilever to a ground bearing structure. We are still liaising with Leviat to try and obtain a root cause of the failures.

- Works were halted whilst an investigation was carried out and a solution found.
- All previously installed threaded bars were removed.
- The procurement team have checked that no other bars have been purchased from Leviat on Client schemes in the last 3 months.
