## Safety Alert 25-87 Cut Injury - Hodssock

### Incident Outline

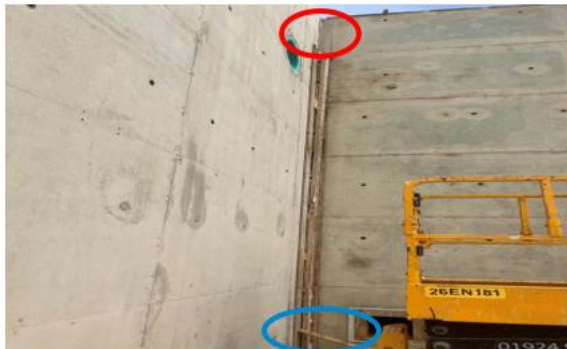
While work was being carried out in the ASP tank near Wall 11, BFS operatives were stripping the main shutter with a crane attached. The IP, positioned on the steel side of a MEWP, levered the shutter away from the wall by approximately 40mm. The IP then descended in the MEWP and moved underneath the area where the shutter was to be removed, positioning on the opposite side of the wall to check that it was free and safe to begin lifting the shutter. During this process of carrying out the final safety check a 4x2 piece of timber became dislodged, fell from the top corner of the wall, approximately 6 m high, striking the IP and causing a cut to the upper lip.

**Photo 1:** Red circle- the location that the timber fell after becoming dislodged before proceeding to lift out the shutter.

Blue circle- A piece of timber fell from the location marked by the red circle and struck the IP on the lip.

During any lifting operation you must have an exclusion zone, so you remain out of the line of fire. If loads need to be guided, other means should be used such as guide ropes. Remember HOSSAS (Hands off, Step Away, Safe Space)

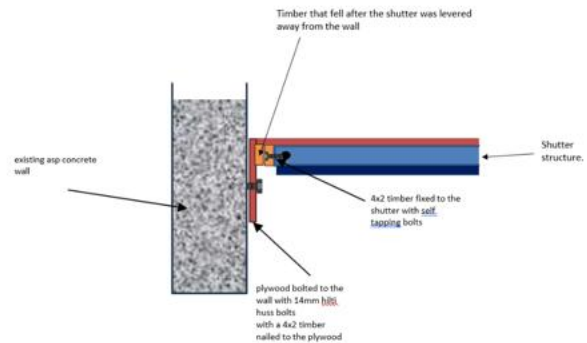
**Photo 2:** Diagram detailing the structural arrangements of the wall/shutter system.
