Safety Alert 25-85 Hose Strike to the Face Resulting in Injury

The following Safety Alert contains content from an external source which is relevant to MWH Treatment Operations

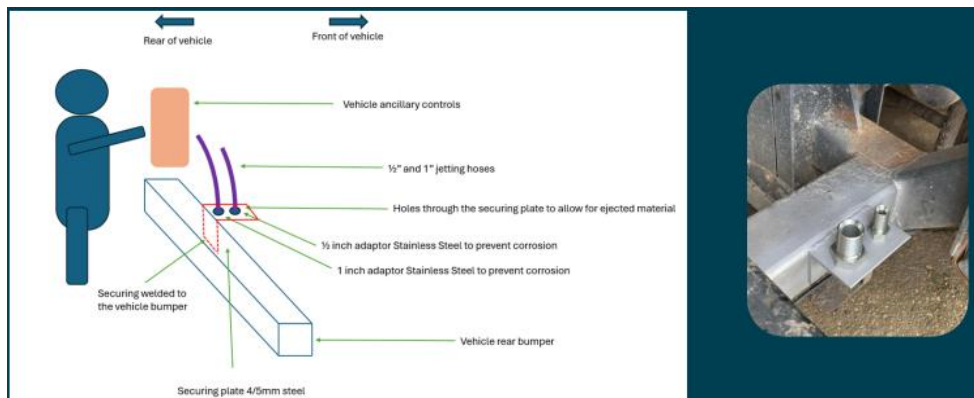
- Increased risk of hose “kick back” in freeze thaw conditions – potential to also occur after transit (associated with windchill)
- There is no facility to purge the jetting system on the 18T jet vacs currently used by the Wet Well Cleansing team. New and hire vehicles do have this facility
- There is no facility to fix the hose (1/2 – inch or 1-inch) during testing and prior to use on the 18T Jet vacs used by the Wet Well Cleansing team.

- In collaboration with Transport, all WWC internal fleet vehicles are being modified to ensure the hose can be securely held in position when testing prior to use with the hose directing downward (see photo and sketch below)
