Safety Alert 24-54 Latent Damage to LV Cable

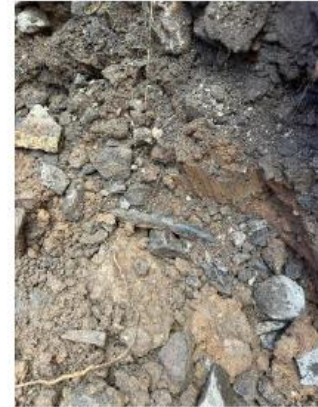
Photo 1: Exposed Cable and stone underneath

After the dig had been conducted, the client raised concerns that they had lost some services, but it was intermittent. Checks were carried out and a potential fault was found in the vicinity of the excavation. The circuit was isolated and under supervision of both the STW and MWH SAPs the cable was exposed to check for damage. The cable was located at the depth identified, but there was no warning tape on top of the cable and the cable had not been protected with sand and fine material. Instead, the cable was laid in a layer of sharp rocky ground. It was confirmed by the SAP that the damaged was caused by a stone under the cable penetrating into the earth cable and causing intermittent service loss.

The cable was repaired, and service was resumed. On inspection of the removed piece of cable it was apparent that the cable had been compressed over some time and this had caused the stone of bite into the cable from below.

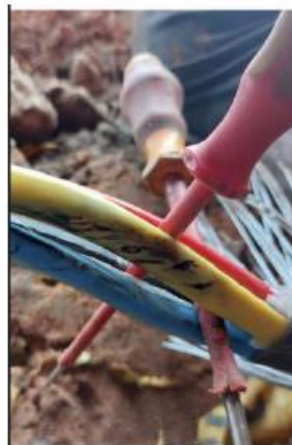
Photo 2: View of removed damaged cable showing compression

- HSG 47 was followed correctly
- The team were trained and competent in cable avoidance
- Vac-ex was used for the majority of the dig
- Poor install of the cable was the main factor in the damage being caused
