Coppermills cross site cable – Main cross site cable sheath test failure

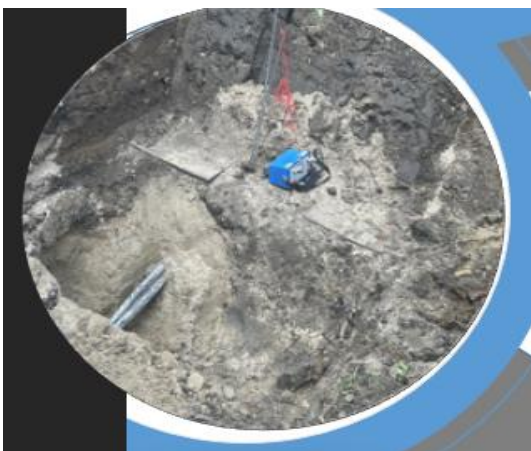
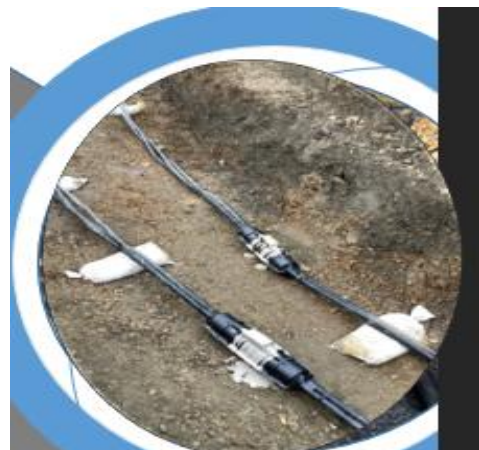
An NCO was raised for the electrical contractor requiring a suitable resolution that ensures all testing is passed. A series of tests were carried out to find locations of failures along the cable, the cable exposed to investigate the extent of damage and a suitable repair method decided upon.

After a long period of testing over multiple visits, damages to the cable sheath were still being found – due to this MWHT condemned the cable requiring a new one to be procured. The damaged locations would require either jointing or sheath repair and due to the extent in number it was unlikely that TW would accept the cable in this condition.

As all the sheath damages were found in the direct buried section of the cable installation, MWHT proposed and agreed with TW to install ducting for the entire route to minimise likelihood of damage or test failure for the new cable.
