Safety Alert 25-75 Facial Injury from Pinch Bar

The following Safety Alert contains content from an external source which is relevant to MWH Treatment Operations

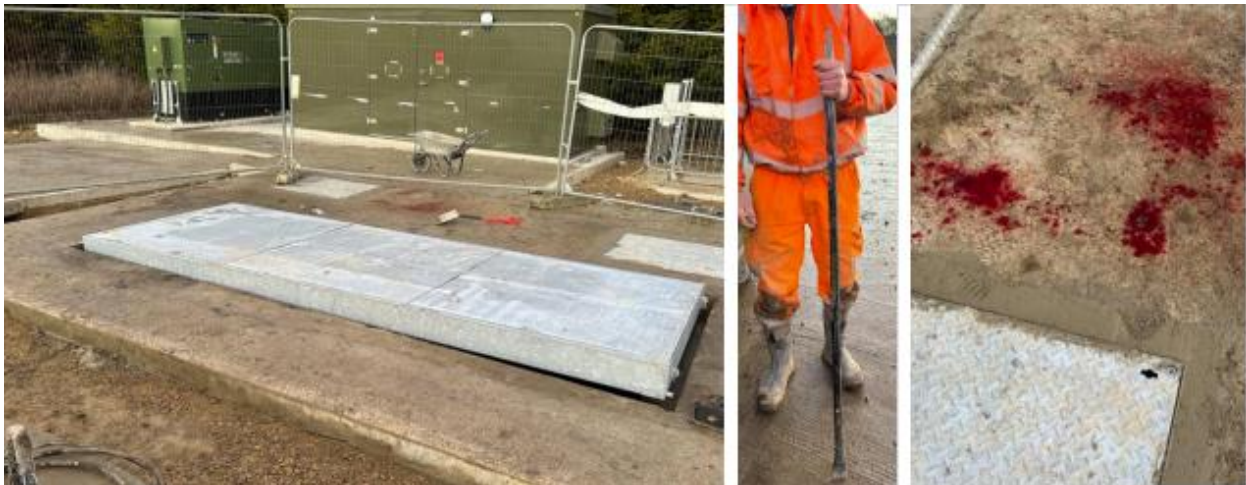
Initial review established that the works involved a suspended cover (held by chains to each corner) with the final lowering into position where it is believed that the bar may have been “nipped” under the edge of the cover resulting in the bar recoiling at excessive force under leverage direct onto the employee’s facial area.

Photo above shows the layout of the site. The IP had been standing approximately where the shovel is located (large quantity of blood on the floor).

Note: The shovel was placed there as a marker for this image and had no impact on the accident.

The chamber cover was suspended on a four-leg chain and being lowered into a recess within the concrete slab. Whilst assisting with guiding the cover, the bar was inserted in the gap between the cover and the concrete and subsequently may have slipped under the edge as it was lowered resulting in a violent spring back (similar to standing on a garden rake).

- Personal positioning on any lifting / lowering tasks to be monitored – remember **HOSSAS (Hands off, Step Away, Safe Space)**
- Assistance on lifting operations to be reviewed – e.g. a tirlor or ratchet pull chains to be considered to locate after being lowered
