Safety Alert 25-77 11Kva Cable Strike

The following Safety Alert contains content from an external source which is relevant to MWH Treatment Operations

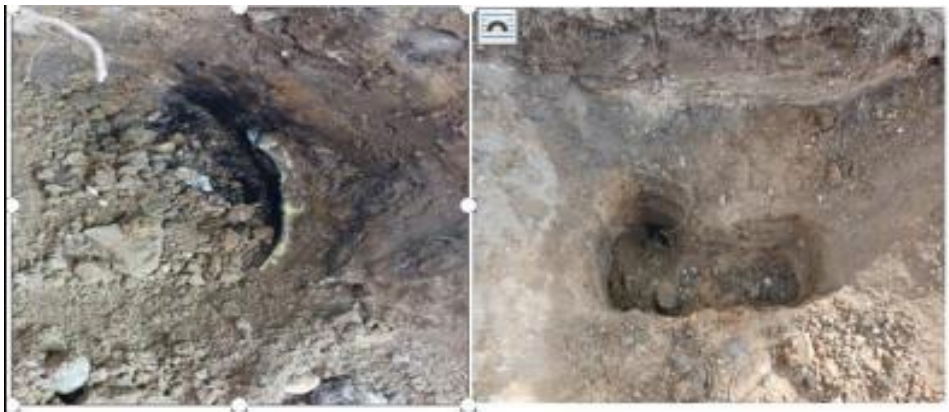
In advance of laying a raw watermains from the existing site to the new site, operatives were tasked with digging trial holes on known services to determine the line and depth of the service, to ensure no impact on the line and level of the mains to be installed. The excavation works proceeded (following a CAT scan to identify the location of the cable) using the hand dig method until they reached the warning tape. The operative then began to dig to the side of the warning tape to further expose the cable and in doing so the spade went through the warning tape and dug into the cable. The ground was stiff clay and there no sand or stone surrounding the cable, so the operative was digging with force. The operative believed that there would be a gap between the warning tape and the cable, but the warning tape was sitting on top of the cables. The cable blew out and went on fire for a short period. The operative was uninjured as he was using fibre glass non-conductive spade.

- Works were stopped and the excavation barriered off.
- UKPN attended site and de-energised the cable. The excavation was then opened up to allow for the repair of the cable
- 2-2-2 process was followed to alert NWL and Farrans Senior Management of the incident
- Investigation took place into how the incident occurred

- When searching for a cable in stiff ground and you come across the warning tape, do not continue to try and further expose the cable with the spade. Excavate to the side of the cable using an excavator (keep 500mm away from the warning tape) and then continue to manually expose around the cable when the material is easier removed.
- Never assume that the warning tape has the recommended required depth between it and the cable
