Safety Alert 25-19 - Damage to Marquee Due to High Winds

Incident summary

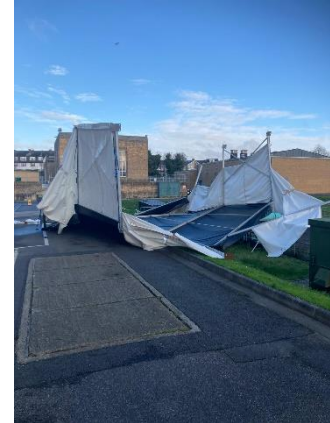
damaged a marquee hired to protect HV drums from adverse weather. As a result, one of the ratchet straps securing the marquee snapped, causing the counterweights to lift and the marquee to overturn.

The cause of the incident was the ratchet strap failure. The investigation found that, although the weather event was unusual, the weather warning wasn't fully assessed on-site as a risk, especially for the marquee. This led to the lack of extra safety measures to handle the weather conditions.

- 1. Improve Risk Assessment when events such as adverse weather warnings are put in place** - Weather warnings must be treated as significant and worst-case site-specific controls put in place to account for any potential consequences. This includes making any temporary structures safe and secure- this may sometimes mean going back to the supplier of temporary structures for further guidance on how to enhance the security/strength of the temporary structure.

- **Consider amendments to the Temporary Works:** if possible, the temporary works should always be taken down where feasible. If this is not possible, then follow manufacturers advice. For this incident, it could have included removing the sides of the marquee, further anchoring the marquee to the ground with stakes or weights, adding sandbags to the base for extra weight, adding wind breaks in around the marquee or looking at hanging the marquee from a sturdy permanent frame or beam.
- **Provide Training and Awareness:** Site teams to be upskilled via Weather Warning Awareness Session including, updating risk of assessments and making the site ready for the event, with case studies of previous lessons learnt and the consequences of non-compliance with relevant procedures.
