Safety Alert 25-01 RIDDOR: Crushed Hand Injury

The following Safety Alert contains content from an external source which is relevant to MWH Treatment Operations

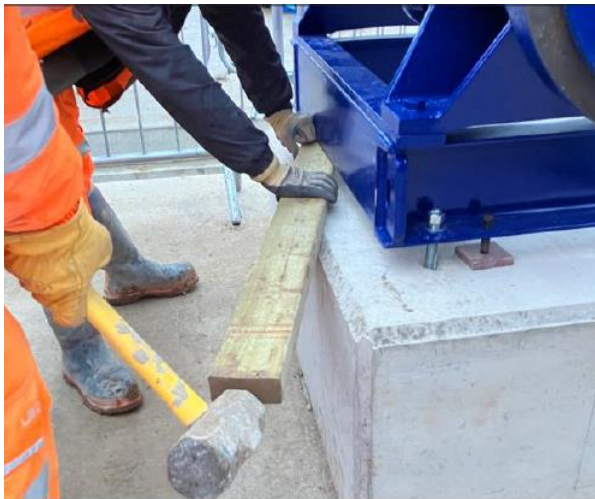
The task was to install a pump on to a raised concrete plinth and involved the lifting and positioning of the pump to align with pre-drilled bolt holes. 7 of the 8 bolts lined up well, but 1 was slightly out of alignment. The contractor requested help to align the final bolt using a length of timber to hammer into position. While the pump was resting on the final bolt, the IP placed their left hand in the 'RED ZONE' on the underside of the pump. The pump lowered suddenly and crushed the IP's hand resulting in several fractures to bones of the hand and fingers. As well as being a 'specified injury' for RIDDOR which requires surgery, this will likely result in a lengthy period where the IP is unable to carry out their normal duties.

Photo 1: Post-incident re-enactment

- The task was immediately stopped and made safe. IP was taken to hospital.
- Mental Health first aid offered to witness by trained site manager.
- Toolbox Talk conducted to refresh the importance of keeping hands clear of RED Zones.
- Controls in RAMS and lift plan subject to comprehensive review and re-approval.

- Identify RED ZONES for lifting activities and communicate using the RAMS and lift plan.
- Prior to any work involving contractors, carry out a talk safe to address task specific hazards.

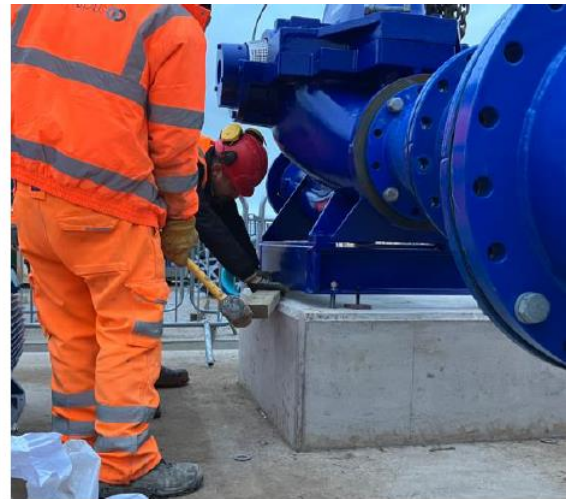
Photo 2: Alternative angle
