## Learning Alert 24-20 WINEP Batch1 – Blyton STW – Wall Collapse

### Incident Summary?

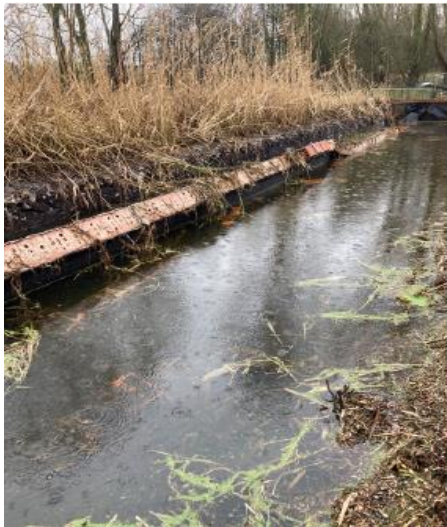
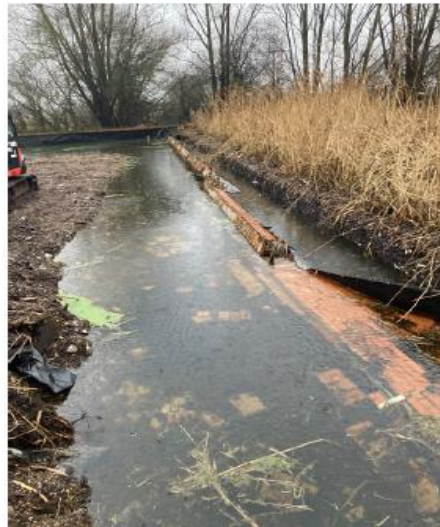
### Photographs

On the afternoon of Tuesday 2nd January 2024, the site team attended Blyton STW after completing their back to work induction, post-Christmas at another local site to conduct site checks prior to starting back to work on Wednesday 3rd. During the visit it was noted that the split wall between reed beds 2 & 3 had collapsed. It is assumed that the failure occurred on the night of the 1st/early hours of the 2nd of January. There would have been no risk to any person/persons, either MWHT or client as no operatives were working in the bed or on site at the time of the incident.

There had been persistent heavy rain on the 1st & 2nd of January causing localised flooding on site and the surrounding area. Following the investigation, the root cause points towards site being surcharged with excessive flow which in turn overwhelmed bed 3. As bed 3 had not yet been refurbished the extra effluent could not percolate through the bed efficiently, so an extra 300 - 400mm of water sat on top of the bed within the walls, the weight of this extra water in turn caused the wall to fail because there was no support from bed 2 as this bed was empty for refurbishment works.

The pipework is to be removed and diverted.

For refurbishment works on reed beds of this type, i.e. of a brick wall construction as opposed to battered earth banks, extra temporary treatment should be utilised to enable multiple beds to be taken offline on any given time. This in turn would mitigate the risk of wall failure as there would be no forces on the split walls from adjacent reed beds. If for whatever reason all beds could not be taken offline for either process or site constraints a temporary works design will be put in place to protect the structure from collapse.
