## Safety Alert 25-84 Non-Injury Service Strike - Signal Cable

### Incident Outline

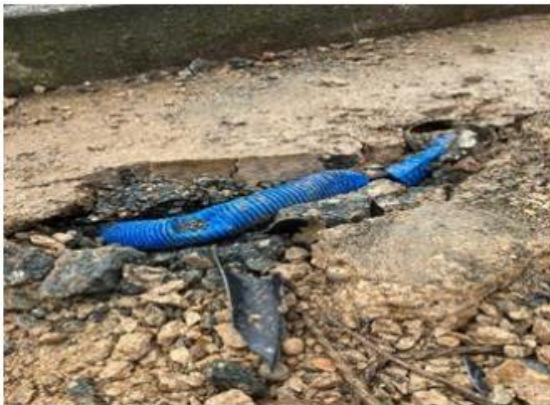
The incident occurred at 09:43 on 23/01/25 whilst removing an existing concrete slab with a breaker, a cable was damaged causing loss of signal from tanks on the works to the control room.

It was not until the broken concrete was being removed that the damage became noticeable to the site team carrying out the work.

Route of cable through slab

- Ensure company standards / SAWG are complied with at all times
- Ensure all are re-assessed on CAT & Genny use (by in house CAT and Genny Guru) / requirements of company standards / SAWG standards
- Ensure all breaking ground is managed using a ground disturbance permit.

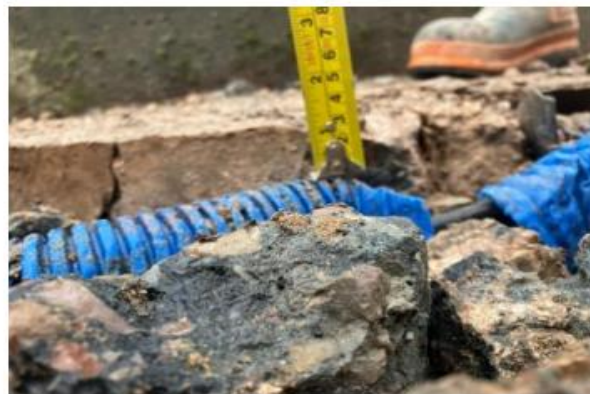
Depth of cable below slab

- Site stood down and investigation commenced
- Severn Trent Water completed repairs the same day
- It was a known service, had been picked up on the GPR survey which stated 250mm depth and was measured at a depth of 250mm in draw pits either site
