## Safety Alert 24-23 Struck by Steel Sheet Pile

On the 6th of March at the Hixon WFD site an operative was struck by a 4.5m long steel sheet pile during the installation of trench supports in an excavation for drainage works within the A51 carriageway. The operative received injuries understood to be a fractured collar bone and pelvis and was taken to hospital via ambulance. The IP currently remains in hospital receiving treatment for their injuries.

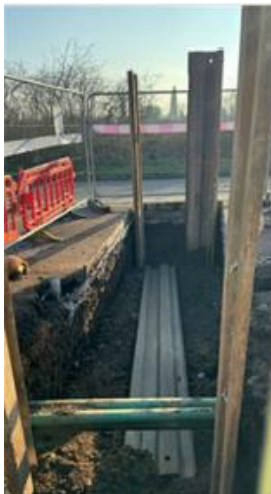
The piles were being lifted into place by an excavator with a 6-tonne quick release pitching shackle and were being installed to establish the trench corners. Following the successful installation of the first 5 sheets, the sixth sheet appears to have been released from the shackle before achieving sufficient toe into the ground to be self-supporting. Whilst the IP, who was setting the location and level of the pile, turned to retrieve a spirit level in the trench, the sheet pile fell along the length of the excavation and struck the IP.

Photo showing fallen sheet pile

- Review all Temporary Works arrangements on live projects.
- Ensure that sheet piles are adequately supported and stable before being released.
- Piling works should be planned and sequenced to ensure piles are supported and restrained at all times.
- If the task, environment, or equipment is not to plan, STOP and re-assess before continuing.
- Full investigation is underway with findings to be shared to prevent reoccurrence.
- HSE notified.

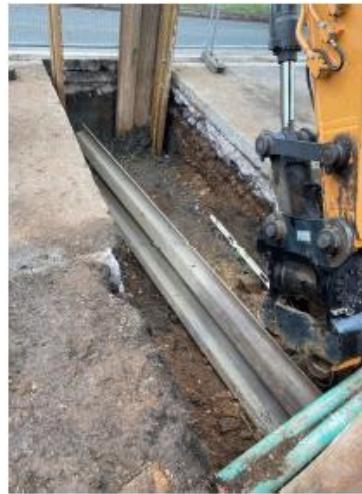
Photo of excavator arm used for task
